Test Results of an Organic Rankine-Cycle Power Module for a Small Community Solar Thermal Power Experiment

(Ford Aerospace and Communications Corporation)

SMALL COMMUNITY
SOLAR THERMAL POWER EXPERIMENT (SCSE)

POWER CONVERSION ASSEMBLY VERIFICATION TEST ON THE TBC
AND ENERGY TRANSPORT SUBSYSTEM QUALIFICATION

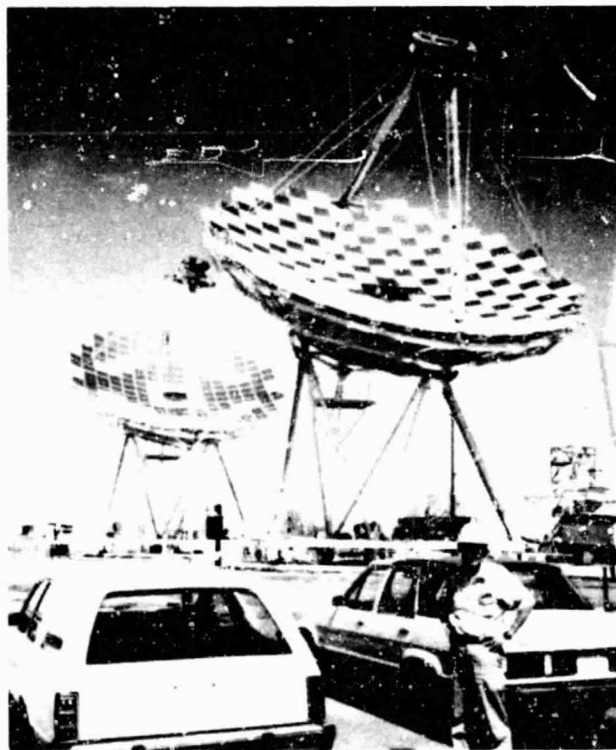
FIGURE 3-4. PHOTOGRAPH OF 50% "CHECKERBOARD" PATTERN. (TEST CONDUCTOR AND APPROVED CARS SHOWN IN FOREGROUND.)

Run 18 (Test 13) had 50 percent masking in an FACC-derived "checkerboard" pattern in which every other mirror was covered. Figure 3-4 is a photograph of this configuration.

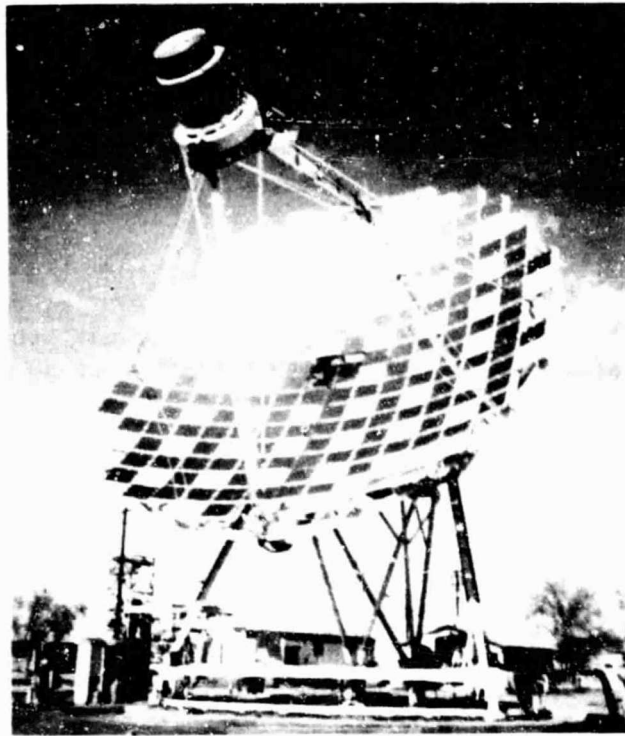
FIGURE 3-5. PHOTOGRAPH OF 25% CHECKERBOARD MASKING PATTERN

The next two runs (19 and 20, Tests 14 and 15) had the 25 percent masking checkerboard pattern shown in Figure 3-5. This pattern was achieved by removing every other covered mirror in the previous 50 percent configuration. A photo of the TV screen showing the "spot" pattern on the back wall of the receiver for the 25 percent checkerboard pattern is presented in Figure 3-6. Each bright spot was from an individual mirror on or near the edge of the dish. Note that this spot pattern was symmetrical and covered most of the back wall. (The no-masking configuration filled in the dark areas shown in Figure 3-6 except for a small region ~4 inch diameter in the center.) The rain water drain in the center of the back wall of the receiver proved to be a valuable aid in determining if the beam was centered with respect to the receiver. Manual adjustment of the concentrator tracking was required to center the beam during periods of low insolation and mid-to-late afternoon operation.

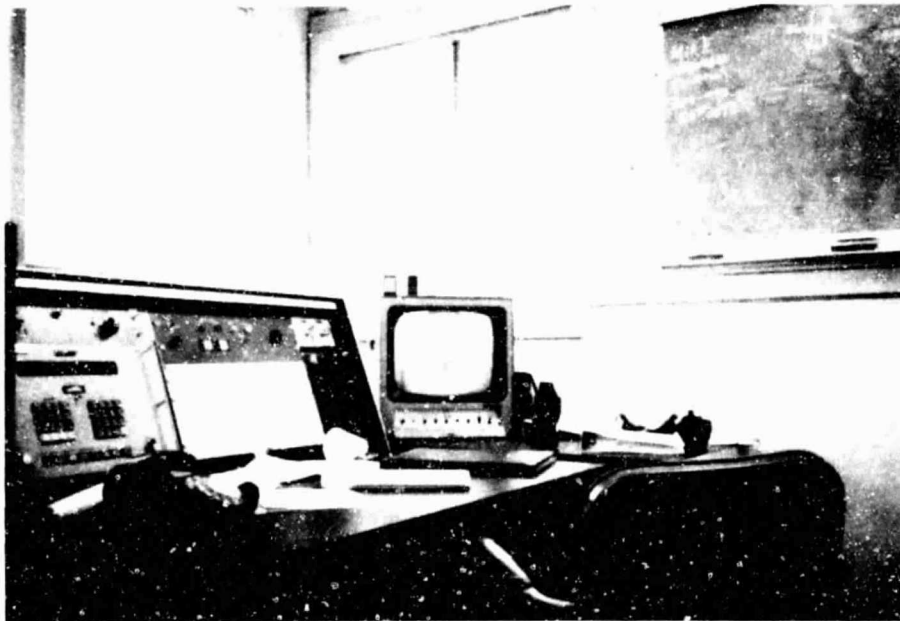
FIGURE 3-6. PHOTOGRAPH OF TV MONITOR SHOWING 25% MASKING SPOTS ON
BACK WALL OF RECEIVER. MODULE IS SEEN THROUGH WINDOW.
